**Flood Control Project Maintenance  
Levee Inspections**

## Maintenance Issue Types Only, Levee Inspection Report By Mile - Spring 2019

### Reclamation District No. 0524 Middle Roberts Island

Waterway	Bank	Unit Miles	Inspection Start/End	Inspector
Unit No. 01 San Joaquin River	Left	6.20	03/26/2019 03/27/2019	Alberto De Leon

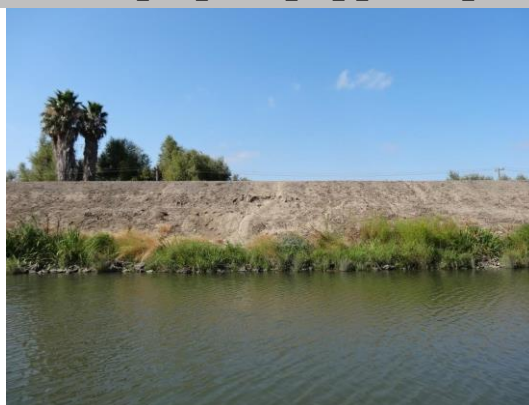
Photo 1 of 3 : SP\_2019\_RD0524\_107\_1\_20190313\_00001.jpg

LM Start	0.19	Rating **	U	Issue No.	1
LM End	0.19	Issue Type +	Ma	Location *	WS
Category	Supplemental			GPS Latitude/Longitude	
				Start	End
Item	DWR Erosion Survey			37.939085 °	37.939085 °
				-121.343917 °	-121.343917 °
DWR ID	RD0524U01RM40.85				
Comment Code					
Inspector Comment					
09/13/2017: No significant change observed.					
07/25/2016: No significant change observed.					
06/24/2015: No significant change observed.					
06/19/2014: No significant change observed.					
08/13/2013: The erosion was discovered during 2013 spring levee inspection. Inspector comment: Erosion is located along the lower level of water-ward slope. [2017 Site ID:RD0524U01RM40.85]

Close view of the erosion.

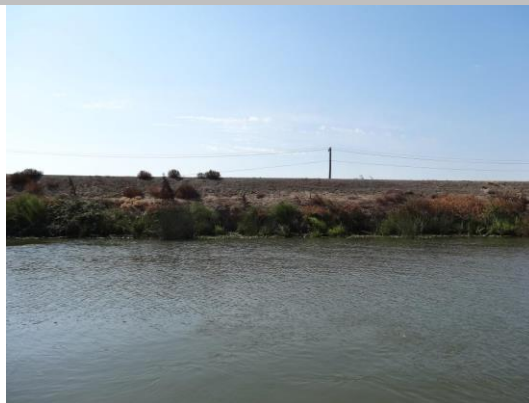
Photo 4 of 4 : SP\_2019\_RD0524\_107\_2\_20190313\_00007.jpg

Front view of the erosion.

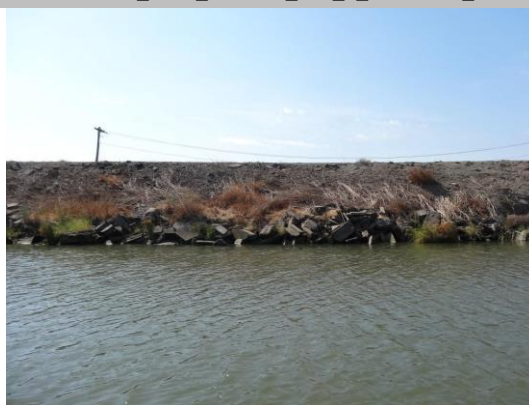
Photo 1 of 4 : SP\_2019\_RD0524\_107\_5\_20190313\_00008.jpg

LM Start	0.40	Rating **	M	Issue No.	5
LM End	0.40	Issue Type +	Ma	Location *	WS
Category	Supplemental			GPS Latitude/Longitude	
				Start	End
Item	DWR Erosion Survey			37.938870 °	37.938870 °
				-121.340460 °	-121.340460 °
DWR ID	RD0524U01RM40.99				
Comment Code					
Inspector Comment					
09/13/2017: No significant change observed. 07/25/2016: More vegetation observed at the site. 06/24/2015: No significant change observed. 06/19/2014: No significant change observed. 08/13/2013: No significant change at this site. 08/07/2012: The erosion is at the upper levee slope, and likely caused by slope slip. The lower levee slope is covered with dense vegetation. [2017 Site ID:RD0524U01RM40.99]

Front view of the erosion site.

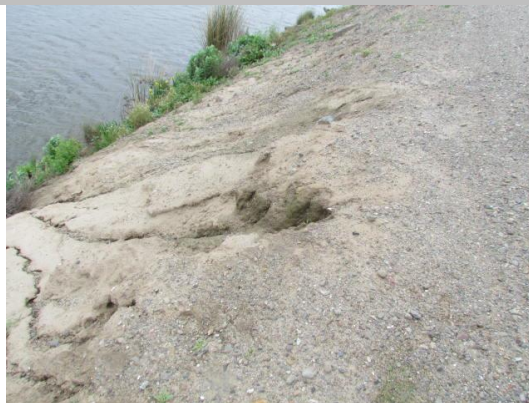
Photo 2 of 3 : SP\_2019\_RD0524\_107\_170\_20190313\_00174.jpg

LM Start	0.43	Rating **	M	Issue No.	170 (cont)	
LM End	0.43	Issue Type +	Ma	Location *	WS	
Category	Earthen Levee			GPS Latitude/Longitude		
				Start		End
Item	Erosion / Bank Caving			37.938669 °		37.938669 °
				-121.340006 °		-121.340006 °
DWR ID	DWR_RD0524_01_s_2015_170					
Comment Code						
E2 : Schedule repair of erosion site prior to the next inspection.						
Inspector Comment						
Erosion on waterside toe, exposed area does not have rip rap

Looking at slope damage on waterward shoulder (Spring 2016)

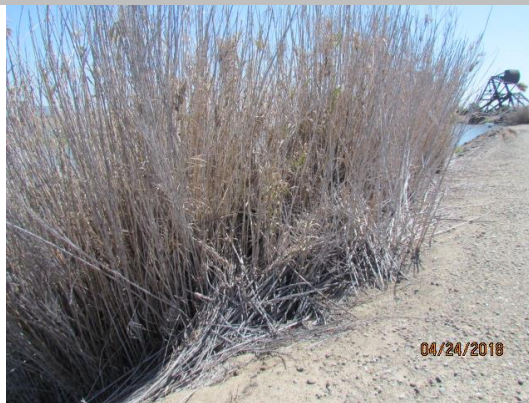
Photo 1 of 2 : SP\_2019\_RD0524\_107\_11\_20190313\_00013.jpg

Looking at bamboo on waterward slope. (Spring 2018)

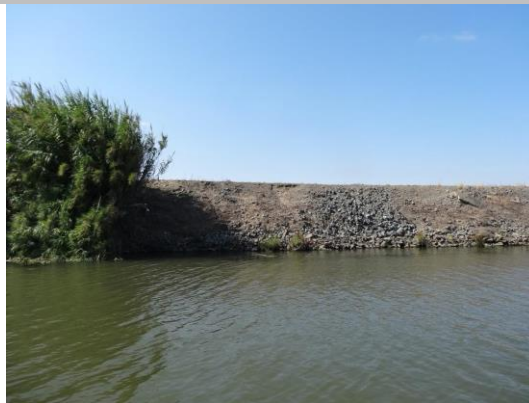
Photo 2 of 2 : SP\_2019\_RD0524\_107\_15\_20190313\_00018.jpg

Front view of the erosion.

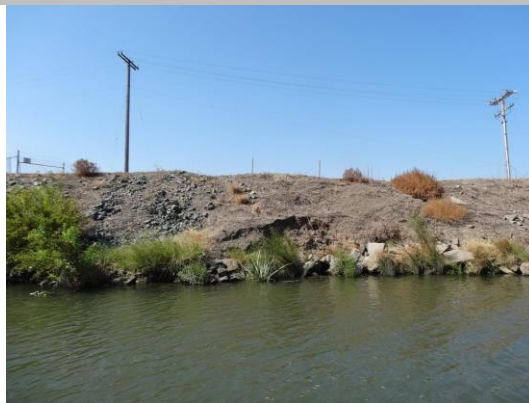
Photo 2 of 4 : SP\_2019\_RD0524\_107\_16\_20190313\_00020.jpg

Close view of the erosion.

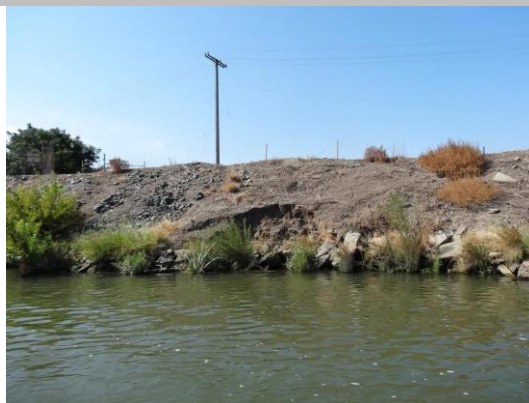
Photo 4 of 4 : SP\_2019\_RD0524\_107\_16\_20190313\_00022.jpg

Close view of the erosion.

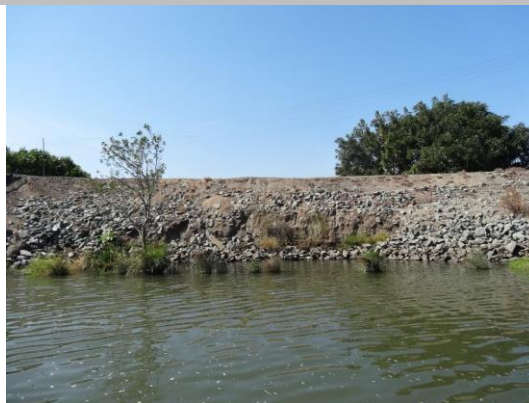
Photo 2 of 3 : SP\_2019\_RD0524\_107\_17\_20190313\_00024.jpg

LM Start	0.71	Rating **	M	Issue No.	17 (cont)	
LM End	0.73	Issue Type +	Ma	Location *	WS	
Category	Supplemental			GPS Latitude/Longitude		
				Start		End
Item	DWR Erosion Survey			37.937222 °		37.937222 °
				-121.335277 °		-121.335277 °
DWR ID	RD0524U01RM41.36					
Comment Code						
Inspector Comment						
09/13/2017: No significant change observed.						
07/25/2016: No significant change observed.						
06/24/2015: The erosion site is immediately downstream of the RR bridge. [2017 Site ID:RD0524U01RM41.36]

Close view of the erosion.

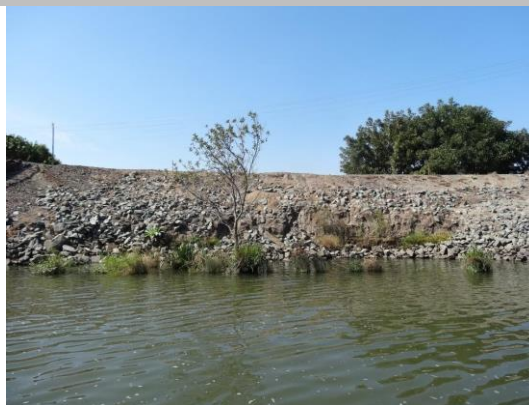
Photo 3 of 3 : SP\_2019\_RD0524\_107\_17\_20190313\_00025.jpg

Close view of the erosion.

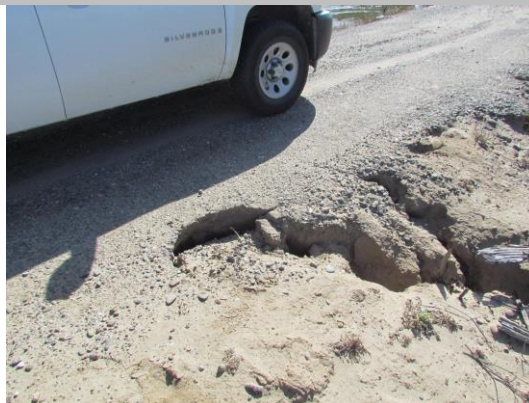
Photo 1 of 2 : SP\_2019\_RD0524\_107\_157\_20190313\_00166.jpg

LM Start	0.72	Rating **	M	Issue No.	157
LM End	0.72	Issue Type +	Ma	Location *	LS
Category	Earthen Levee			GPS Latitude/Longitude	
				Start	End
Item	Erosion / Bank Caving			37.937290 °	37.937290 °
				-121.335417 °	-121.335417 °
DWR ID	DWR_RD0524_01_s_2017_157				
Comment Code					
E2 : Schedule repair of erosion site prior to the next inspection.					
Inspector Comment					
Slope damage caused by rain runoff on landside slope.

Looking west at slope damage caused by rain runoff on landward slope.

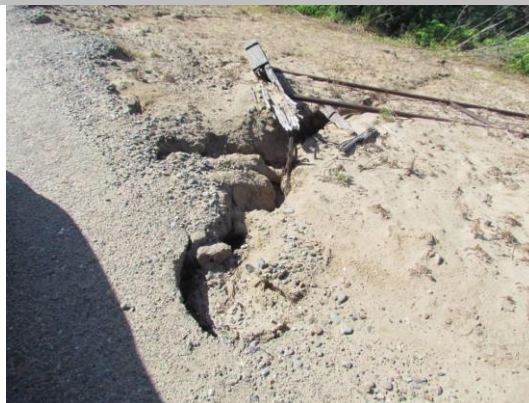
Photo 2 of 2 : SP\_2019\_RD0524\_107\_157\_20190313\_00167.jpg

LM Start	0.72	Rating **	M	Issue No.	157 (cont)	
LM End	0.72	Issue Type +	Ma	Location *	LS	
Category	Earthen Levee			GPS Latitude/Longitude		
				Start		End
Item	Erosion / Bank Caving			37.937290 °		37.937290 °
				-121.335417 °		-121.335417 °
DWR ID	DWR_RD0524_01_s_2017_157					
Comment Code						
E2 : Schedule repair of erosion site prior to the next inspection.						
Inspector Comment						
Slope damage caused by rain runoff on landside slope.

Looking south at slope damage caused by rain runoff on landward slope.

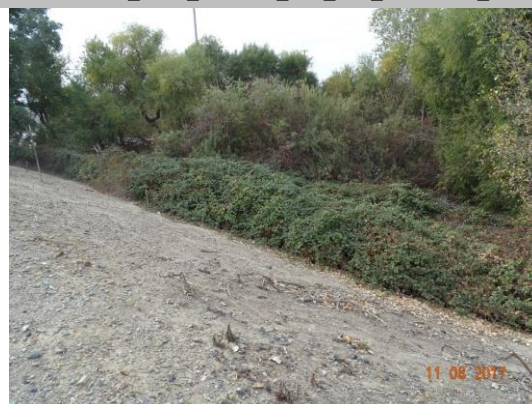
Photo 1 of 3 : SP\_2019\_RD0524\_107\_262\_20190313\_00272.jpg

LM Start	0.75	Rating **	U	Issue No.	262
LM End	0.78	Issue Type +	Ma	Location *	LS
Category	Earthen Levee			GPS Latitude/Longitude	
				Start	End
Item	Vegetation			37.936813 °	37.936539 °
				-121.335019 °	-121.334863 °
DWR ID	DWR_RD0524_01_s_2012_262				
Comment Code					
V2 : Remove the wild growth other than native grasses from the levee slopes.					
Inspector Comment					
Dense vegetation at landside toe along fence line.

Looking northeast at the landside slope.

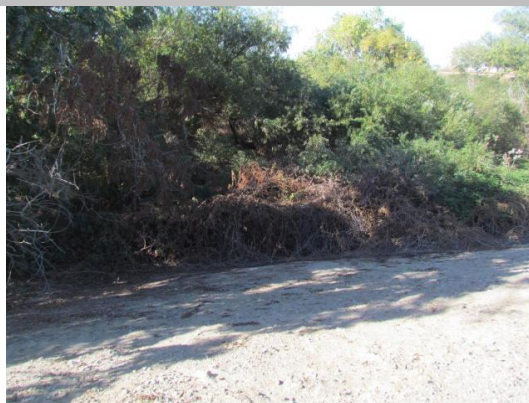
Photo 3 of 3 : SP\_2019\_RD0524\_107\_262\_20190313\_00274.jpg

Looking west at dense vegetation on landside toe. Spring 2014

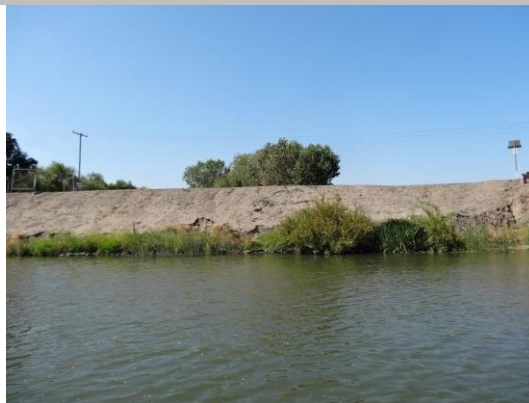
Photo 1 of 4 : SP\_2019\_RD0524\_107\_21\_20190313\_00030.jpg

LM Start	0.76	Rating **	U	Issue No.	21
LM End	0.77	Issue Type +	Ma	Location *	WS
Category	Supplemental			GPS Latitude/Longitude	
				Start	End
Item	DWR Erosion Survey			37.936821 °	37.936821 °
				-121.334582 °	-121.334582 °
DWR ID	RD0524U01RM41.39				
Comment Code					
Inspector Comment					
09/13/2017: No significant change observed.					
07/25/2016: No significant change observed.					
06/24/2015: No significant change observed.					
06/19/2014: No significant change observed.					
08/13/2013: No significant change at this site.					
08/07/2012: The site has been visited by boat survey. No significant change observed.					
08/23/2011: The site is located immediately upstream of a Railroad bridge. Dense vegetation at the water line blocks the view of erosion.					
[2017 Site ID:RD0524U01RM41.39]

Front view of the erosion site.

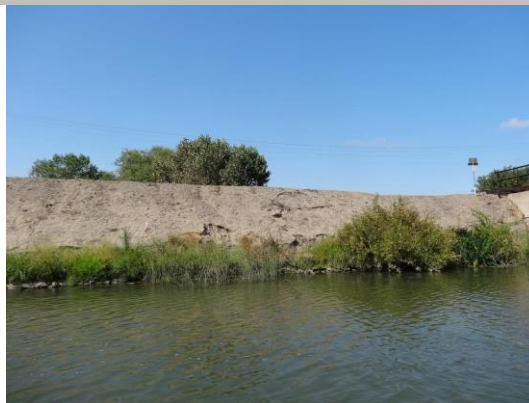
Photo 3 of 4 : SP\_2019\_RD0524\_107\_21\_20190313\_00032.jpg

Front view of the erosion.

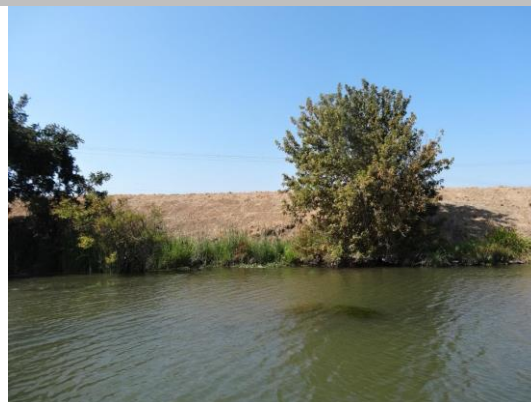
Photo 1 of 2 : SP\_2019\_RD0524\_107\_22\_20190313\_00034.jpg

LM Start	0.83	Rating **	U	Issue No.	22
LM End	0.84	Issue Type +	Ma	Location *	WS
Category	Supplemental			GPS Latitude/Longitude	
				Start	End
Item	DWR Erosion Survey			37.935930 °	37.935930 °
				-121.334133 °	-121.334133 °
DWR ID	RD0524U01RM41.44				
Comment Code					
Inspector Comment					
09/13/2017: No significant change observed.					
07/25/2016: No significant change observed.					
06/24/2015: No significant change observed.					
06/19/2014: No significant change observed.					
08/13/2013: Site was discovered during boat survey. The dense vegetation blocks a clear view of the erosion. Size of erosion site was very roughly estimated. [2017 Site ID:RD0524U01RM41.44]

Front view of the erosion. The tree and vegetation block the view of the site.

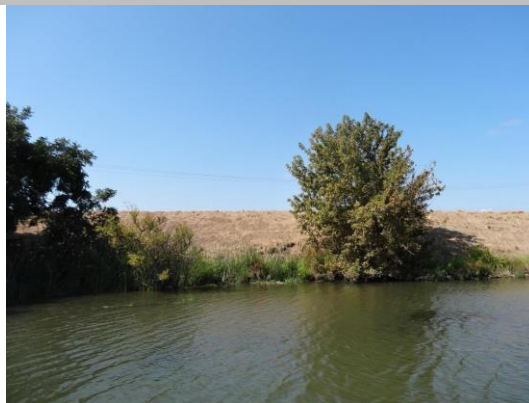
Photo 2 of 2 : SP\_2019\_RD0524\_107\_22\_20190313\_00035.jpg

Close view of the erosion site.

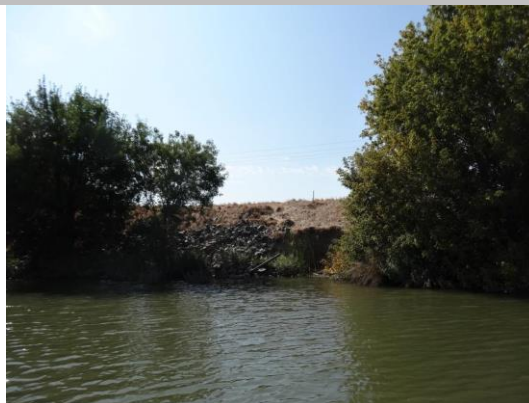
Photo 1 of 3 : SP\_2019\_RD0524\_107\_29\_20190313\_00044.jpg

Front view of the erosion. Note the riprap protection near the site.

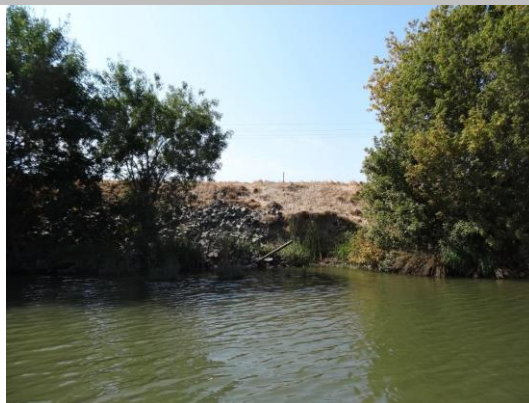
Photo 3 of 3 : SP\_2019\_RD0524\_107\_29\_20190313\_00046.jpg

Close view of the erosion.

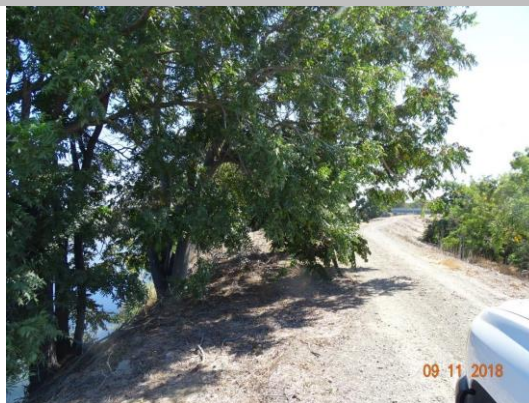
Photo 1 of 1 : SP\_2019\_RD0524\_107\_20\_20190313\_00029.jpg

Looking southeast at untrimmed tree on waterward slope.(Fall 2018)

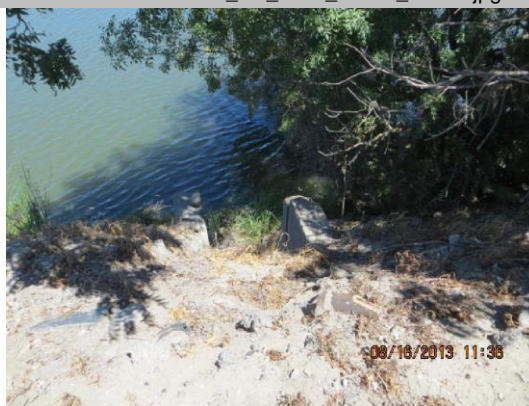
Photo 1 of 2 : UCIP\_SP\_2019\_17575\_29736.jpg

Concrete headwall visible on WS slope.

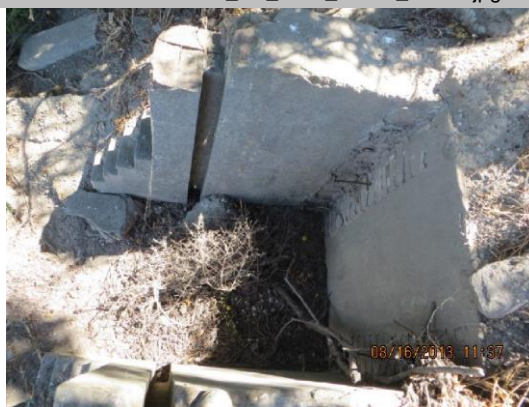
Photo 2 of 2 : UCIP\_SP\_2019\_17575\_29735.jpg

Slide gate removed from headwall on WS slope.

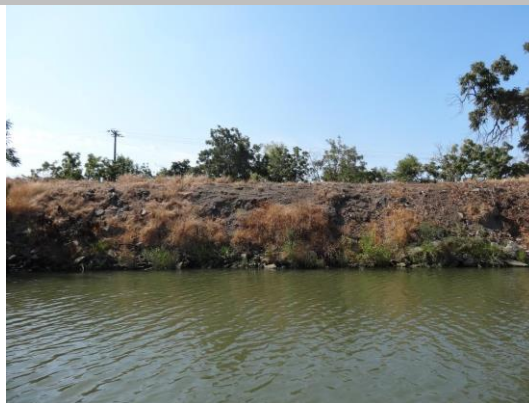
Photo 1 of 4 : SP\_2019\_RD0524\_107\_30\_20190313\_00047.jpg

Front view of the erosion.

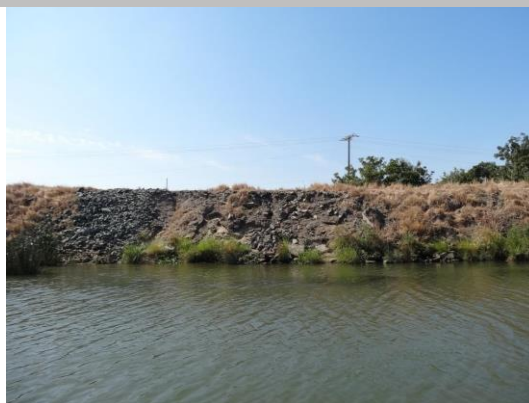
Photo 2 of 3 : SP\_2019\_RD0524\_107\_33\_20190313\_00052.jpg

Close view of the erosion.

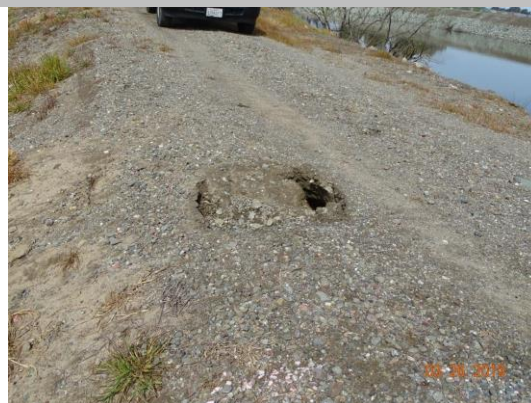
Photo 1 of 3 : SP\_2019\_RD0524\_107\_238\_20190328\_00392.jpg

Large rodent hole landside shoulder looking downstream. Spring 2019.

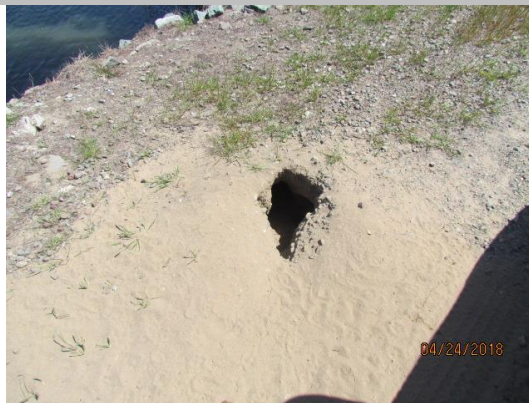
Photo 1 of 3 : SP\_2019\_RD0524\_107\_150\_20190313\_00150.jpg

Looking at close-up view of rodent hole on waterward shoulder. (Spring 2018)

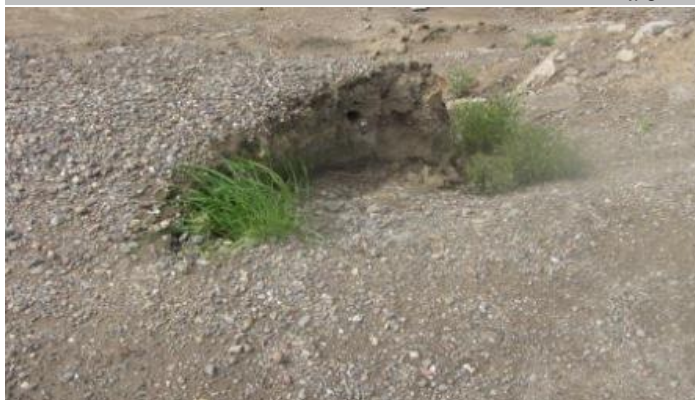
Photo 2 of 2 : SP\_2019\_RD0524\_107\_18\_20190313\_00027.jpg

Updated view from above the slope stability.

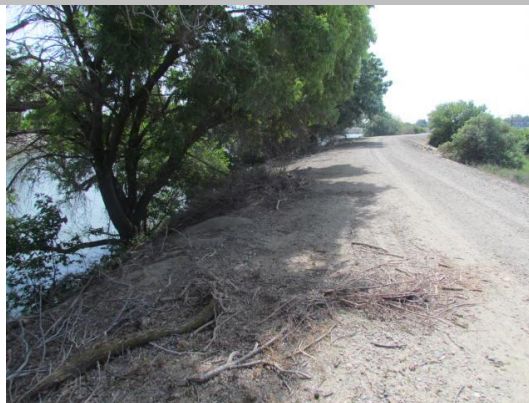
Photo 1 of 1 : SP\_2019\_RD0524\_107\_171\_20190313\_00176.jpg

Looking south at prunings on waterward shoulders.

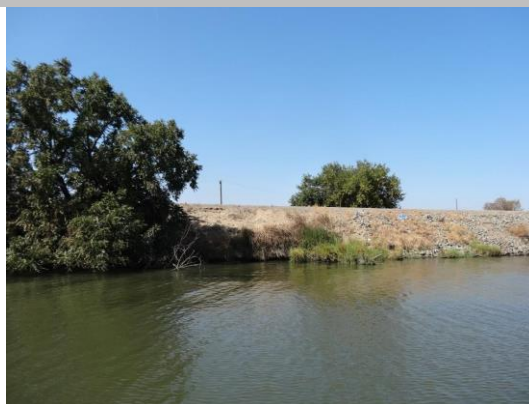
Photo 4 of 4 : SP\_2019\_RD0524\_107\_44\_20190313\_00061.jpg

View of the site. Note the tree near the erosion site.

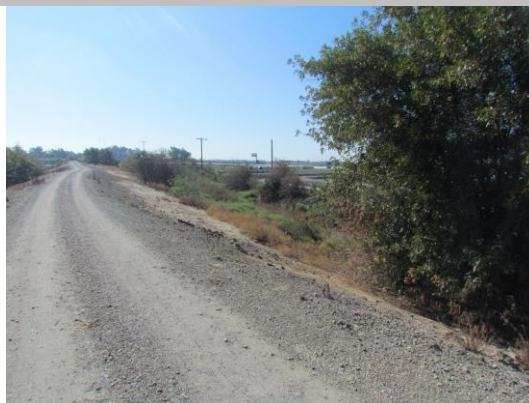
Photo 1 of 1 : SP\_2019\_RD0524\_107\_915\_20190313\_000284.jpg

Looking southwest at dense veg at landward toe and berm. (Fall 2016)

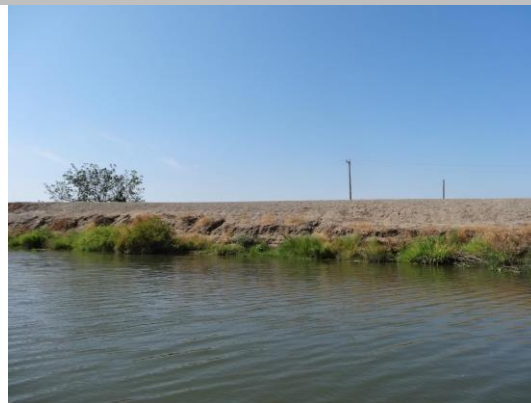
Photo 1 of 4 : SP\_2019\_RD0524\_107\_47\_20190313\_00066.jpg

Front view of the erosion.

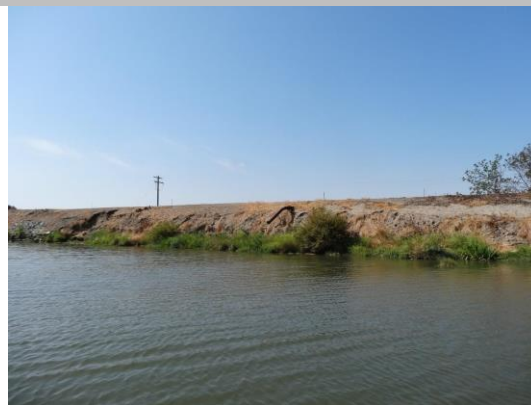
Photo 2 of 4 : SP\_2019\_RD0524\_107\_47\_20190313\_00067.jpg

Front view of the erosion.

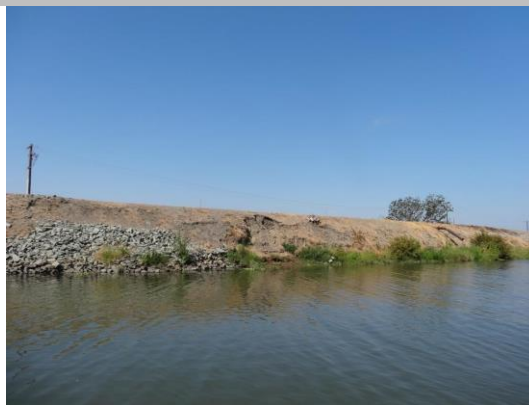
Photo 4 of 4 : SP\_2019\_RD0524\_107\_47\_20190313\_00069.jpg

Front view of the erosion. Note the worsen erosion next to the protected slope.

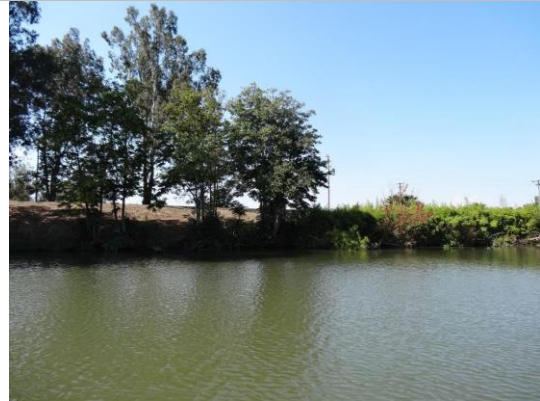
Photo 3 of 3 : SP\_2019\_RD0524\_107\_62\_20190313\_00090.jpg

Front view of the erosion. Dense vegetation is visible.

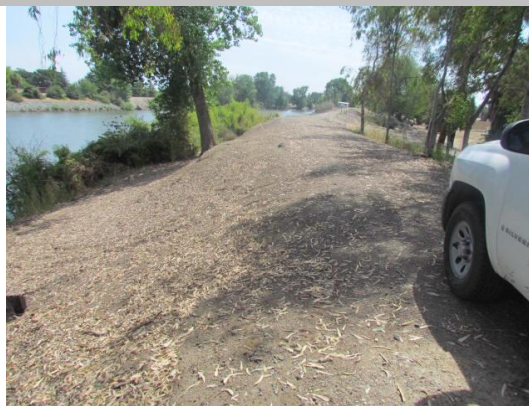
Photo 1 of 1 : SP\_2019\_RD0524\_107\_27\_20190313\_00042.jpg

Looking south at landward slope depression.

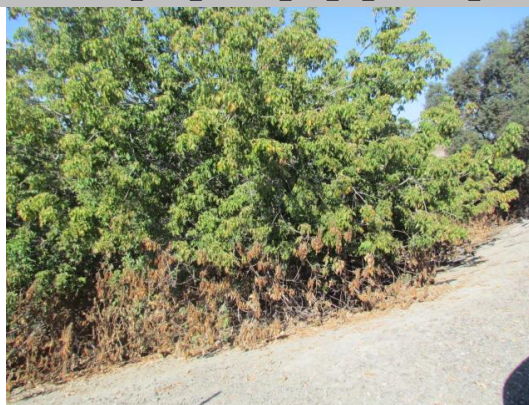
Photo 1 of 2 : SP\_2019\_RD0524\_107\_51\_20190313\_00071.jpg

Looking south at dense trees on landward slope fall 2015

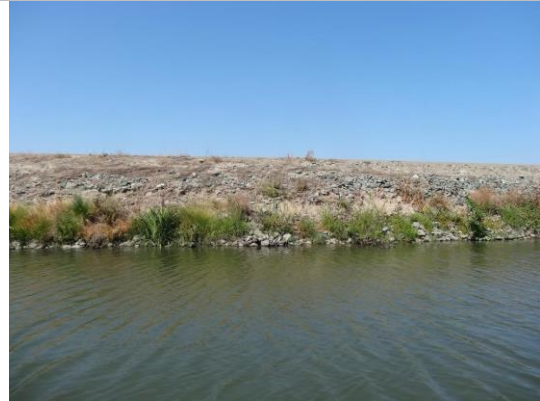
Photo 4 of 4 : SP\_2019\_RD0524\_107\_71\_20190313\_00101.jpg

Close view of the erosion. Note the new pocket erosion next to the irrigation pipe on the site.

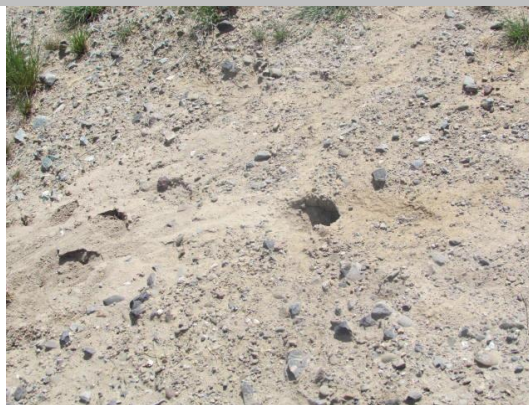
Photo 3 of 3 : SP\_2019\_RD0524\_107\_925\_20190313\_00291.jpg

Looking at typical rodent holes on landward slope along this reach.

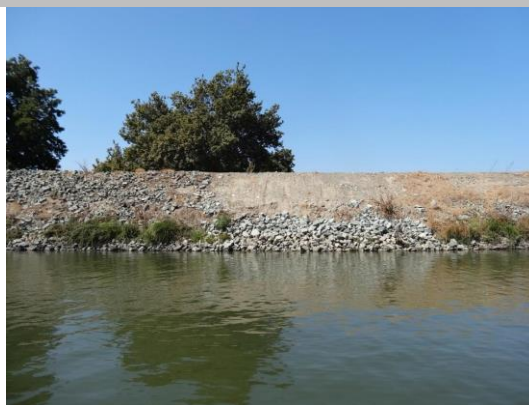
Photo 3 of 4 : SP\_2019\_RD0524\_107\_79\_20190313\_00110.jpg

Close view of the erosion. Note the river rocks and vegetation at the levee toe.

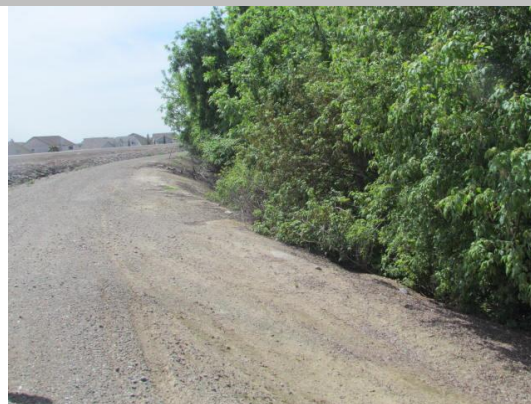
Photo 1 of 1 : SP\_2019\_RD0524\_107\_57\_20190313\_00080.jpg

LM Start	3.53	Rating **	M	Issue No.	57
LM End	3.60	Issue Type +	Ma	Location *	LS
Category	Earthen Levee			GPS Latitude/Longitude	
				Start	End
Item	Trim / Thin Trees			37.905280 °	37.904475 °
				-121.323840 °	-121.324409 °
DWR ID	DWR_RD0524_01_s_2012_57				
Comment Code					
T3 : Trim and thin trees to allow visibility of the ground and room to flood fight.					
Inspector Comment

Looking south at dense trees on landward slope.

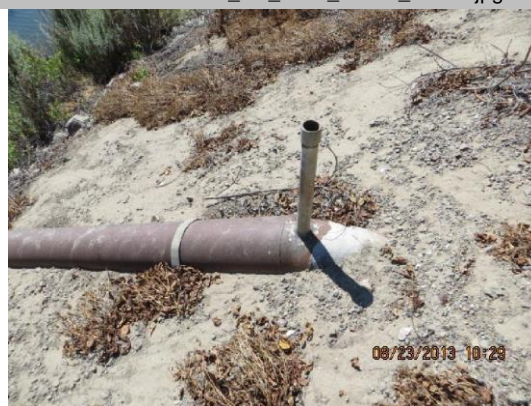
Photo 2 of 3 : UCIP\_SP\_2019\_53358\_30688.jpg

Vent on pipe on WS slope. Possible slurry standpipe that has not yet been used.

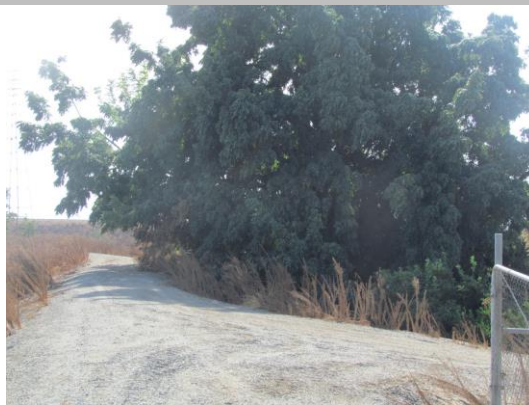
Photo 1 of 1 : SP\_2019\_RD0524\_107\_73\_20190313\_00102.jpg

Looking southwest at large untrimmed tree on landward slope.

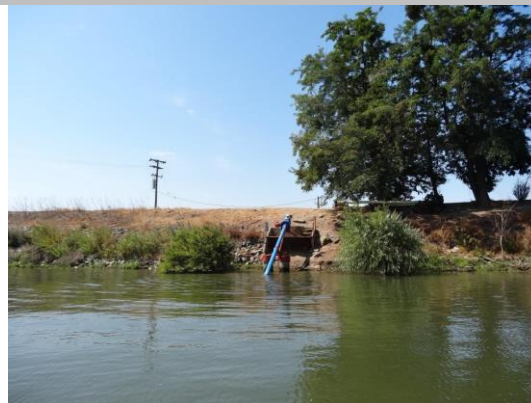
Front view of the erosion.

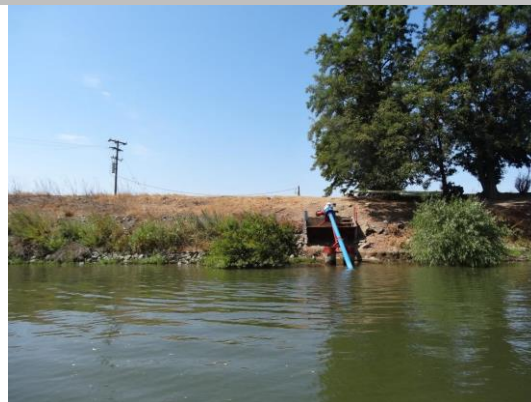
Close view of the site.
